LOCHMERE DAM

NH 00015

PHASE I INSPECTION REPORT  
NATIONAL DAM INSPECTION PROGRAM

NOVEMBER 1978

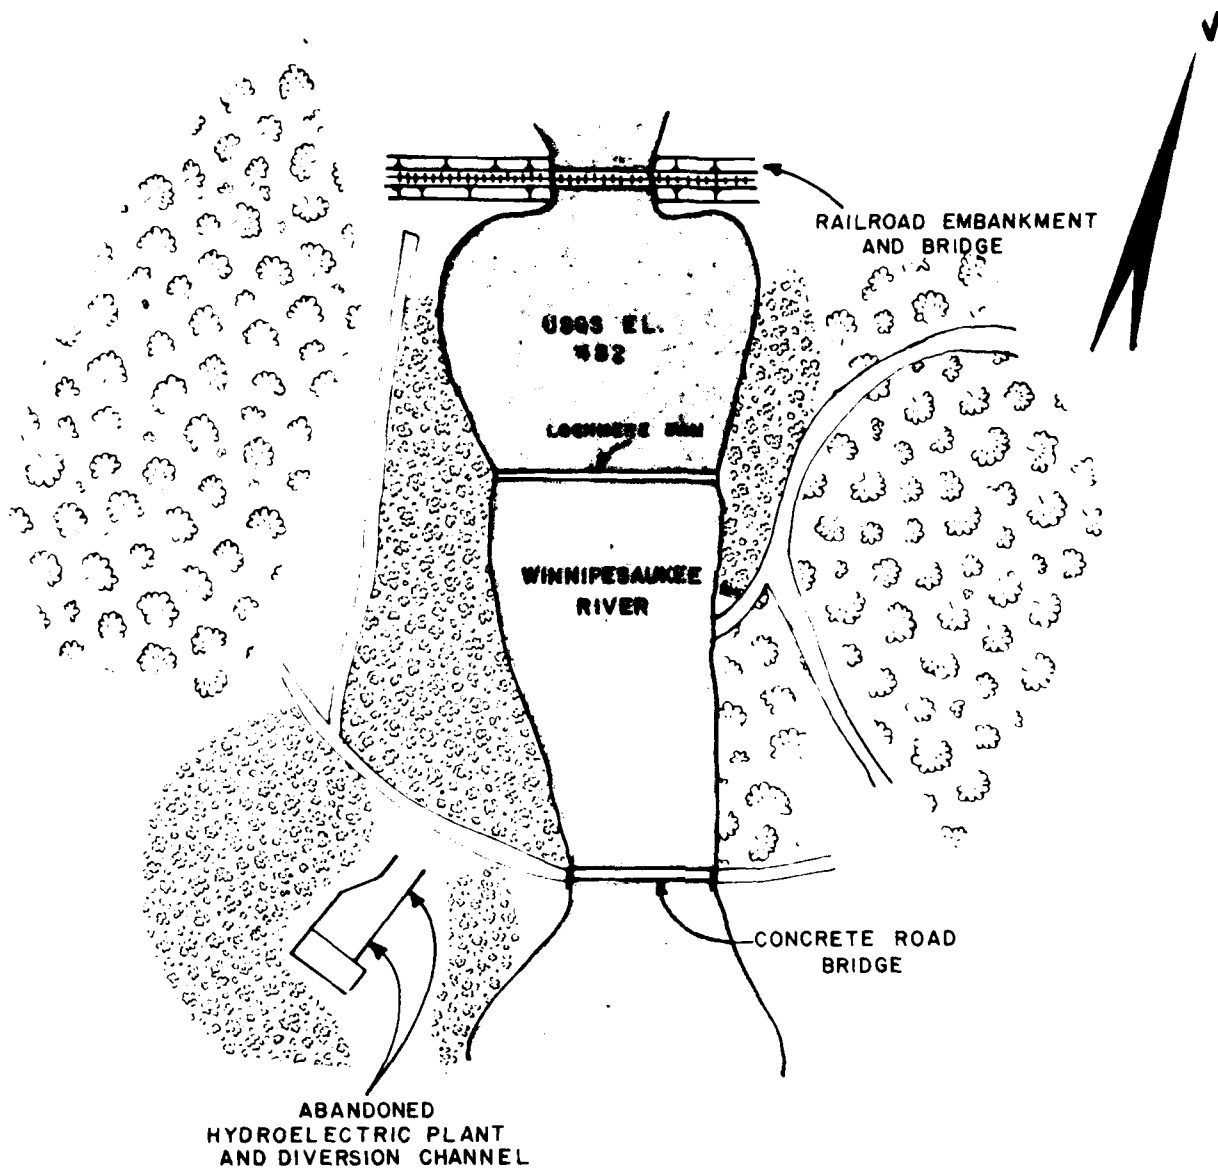
FIGURE 1

The Lochmere Dam lies on the Winnepesaukee River approximately 0.4 miles southeast of the village of East Tilton, N.H. The site is easily accessible via Routes 3/11. The portion of the USGS Penacook, NH quadrangle presented previously shows this locus. Figure 1 of Appendix B presents a detail of the site developed from the inspection visit and the map.
